## 1935 BSA Light Delivery Van

## Restoration Beings

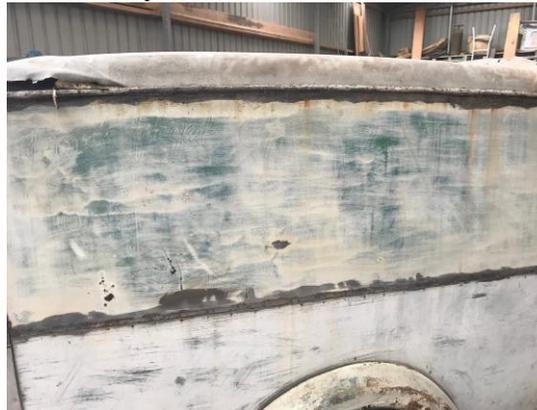
**Sign writing**

The sign written side panels photographed then carefully removed and stored as we want to reproduce the advertising when finished

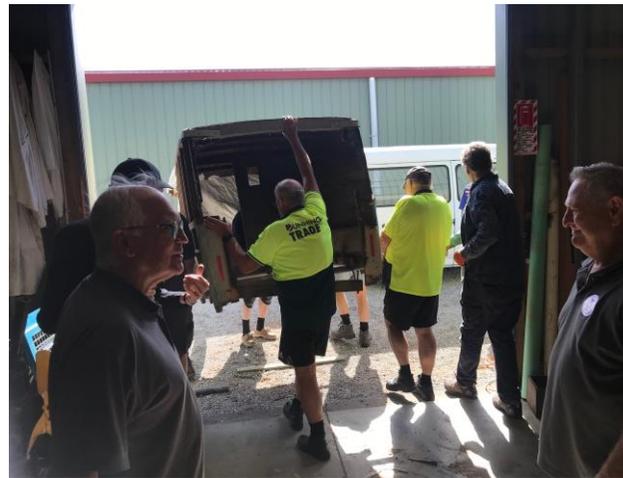
**Body on its way to storage**

The woodwork was in a bad way with rot, so removed with care and the rear van body removed on a jig and stored as one piece for work on it later

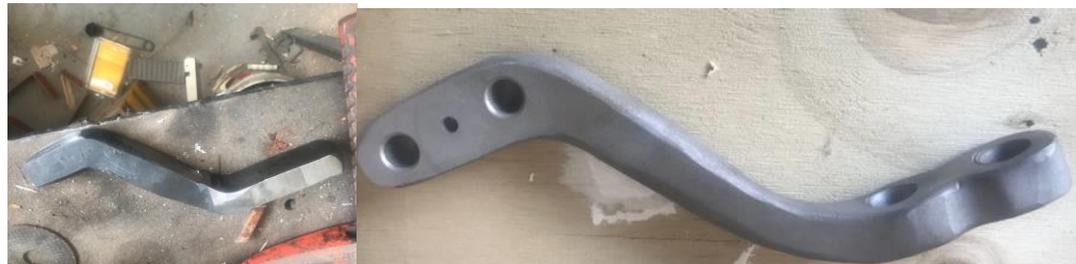
The chassis had suffered some serious damage from its connection with the tree, also the suspension. The front axle is twisted and the drop arm had been broken and crudely brazed up. Steering linkages also broken and a piece of angle iron brazed between the break.

The club is fortunate that some of its team are engineers so a new tie rod has been made. The drop arm was more of a problem as no replacement could be found so a bar of high tensile was forged into a rough shape so with a lot of grinding and machining we now have a better than new arm
