## 1935 BSA Light Delivery Van

## Restoration Beings

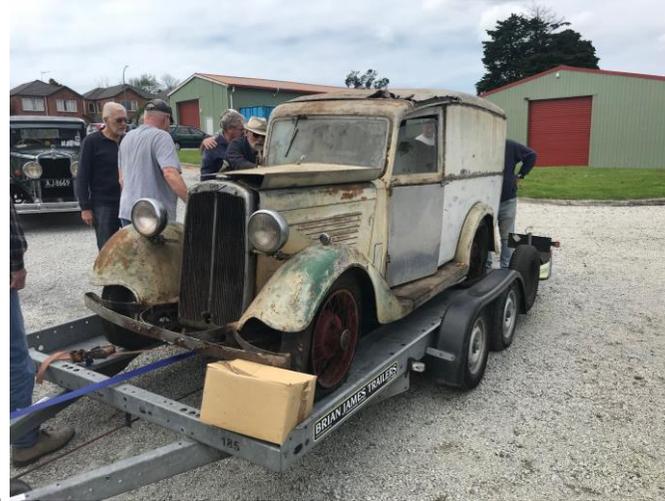
Discussions with Harold Kidd as he had owned 2 ex P&T ones found in Rotorua in the 60s, he backgrounded the history and said he had found records in the Turnbull Library of the cars for Meat deals but only 7 vans were in the deal. With this history the club went ahead as it will be a great restoration
